Rimkus Consulting Group, Inc.
Eight Greenway Plaza, Suite 500
Houston, TX 77046
(800) 580-3228 Telephone
(713) 623-4357 Facsimile

Re: RCG File No: 11009971
LLV Number: 0209452
VMF Location: 1530 Greensmark Drive in Houston, Texas
Subject: Final Report

Rimkus Consulting Group, Inc. was retained to examine LLV 0209452, VIN 1GBCS10E4M2908832. The fire occurred on June 13, 2016 at around 12:30 P.M. the operator of the vehicle at the time of the fire, was unavailable for interview but reportedly stated the vehicle's engine died while delivering mail on his route and backfired during subsequent attempts to restart it. Soon thereafter, smoke was observed from beneath the hood as well as flames.

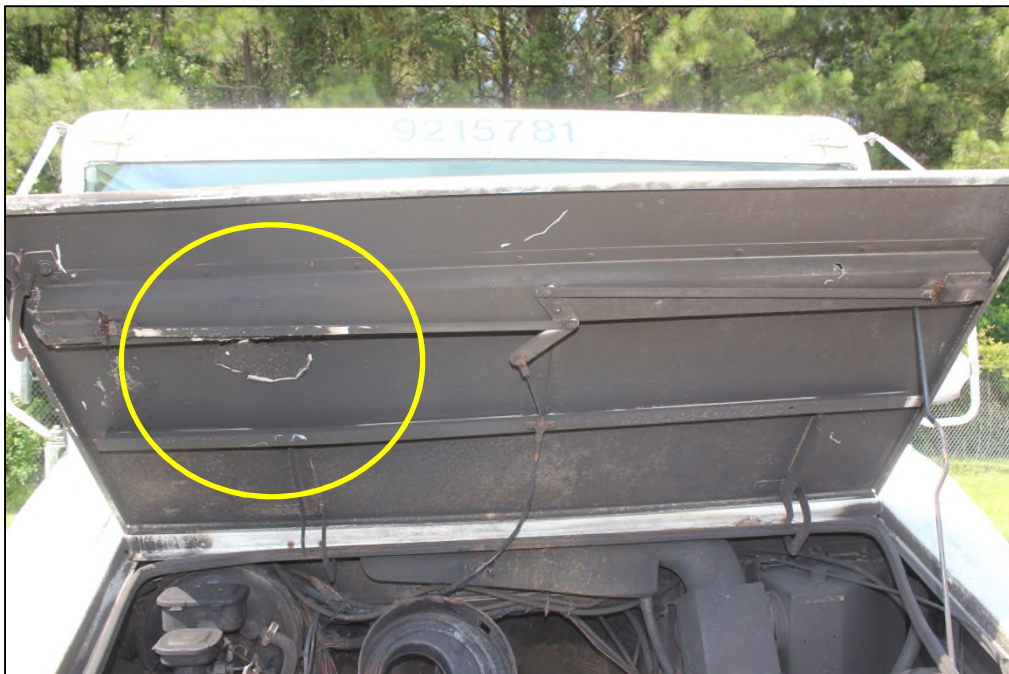
Photograph 8

Engine compartment hood, observe the fire damage to the driver's side of the hood.

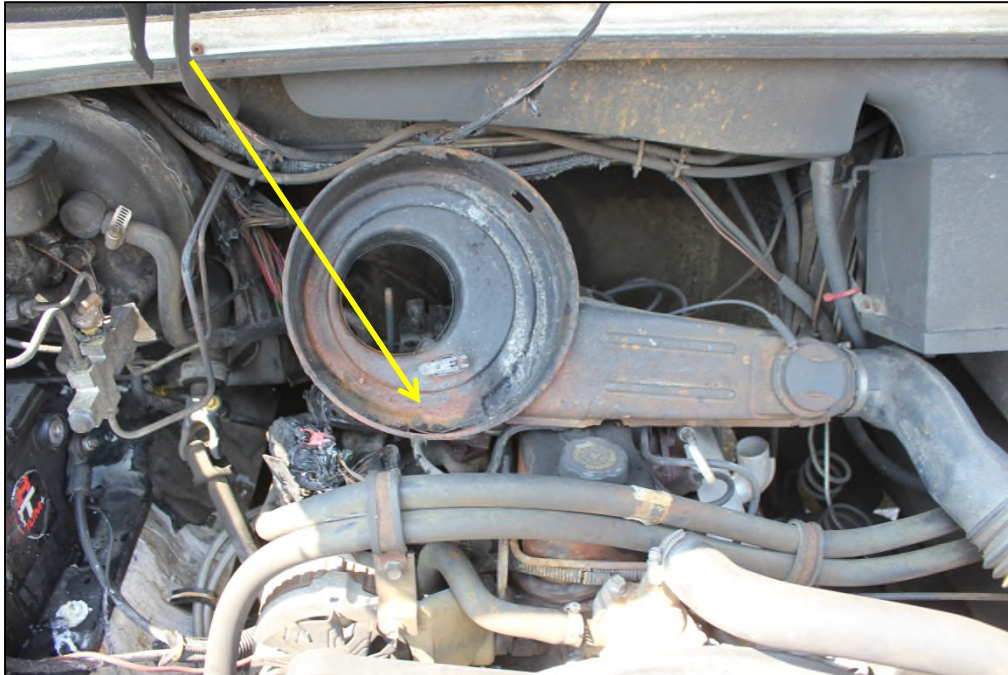
Photograph 9

Engine compartment and lower portion of the air filter housing; observe the fire damage to the interior portion of the air filter housing.

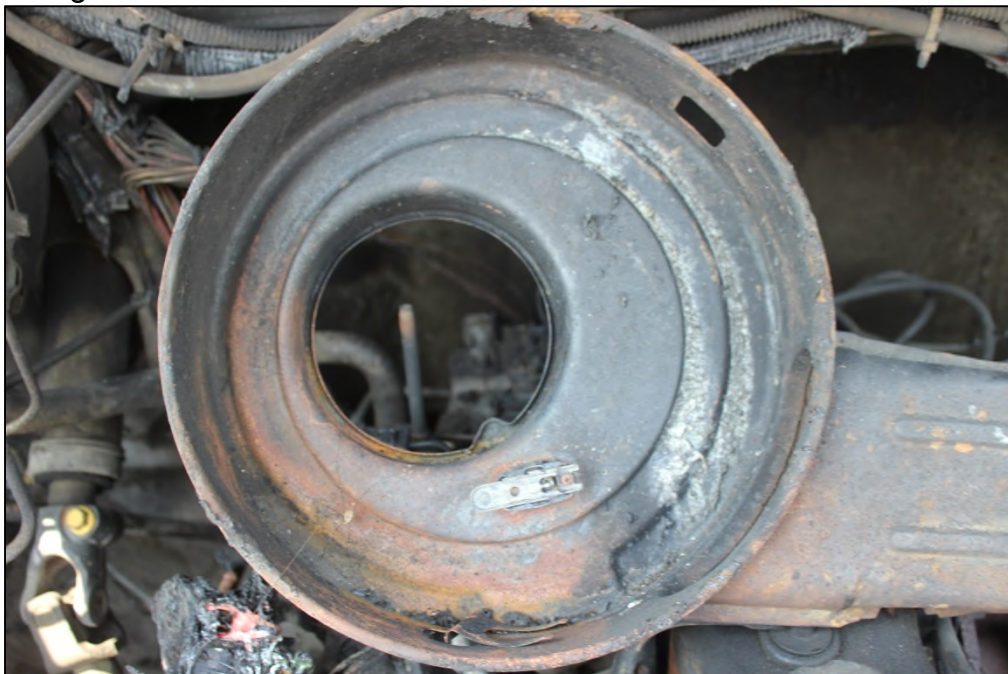
Photograph 10

The lower portion of the air filter housing, observe the fire damage to the interior portion of the housing.

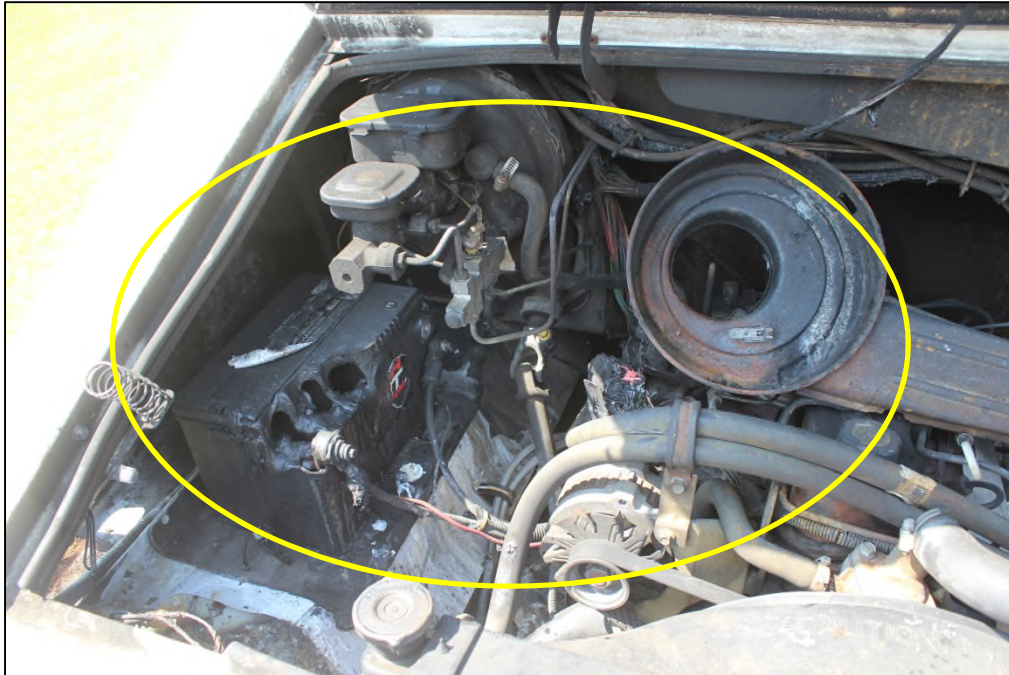
Photograph 11

The driver's side area of the engine compartment, observe the thermal damage to the battery and the components in the area.

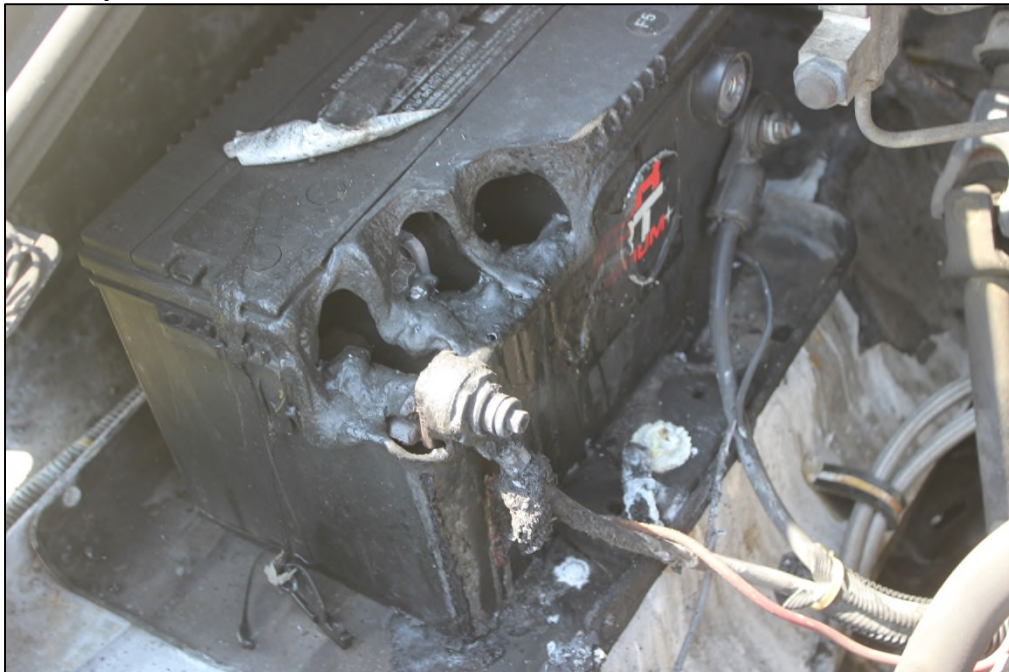
Photograph 12

A closer view of the battery, battery terminals, and battery cables; observe no adverse electrical activity.

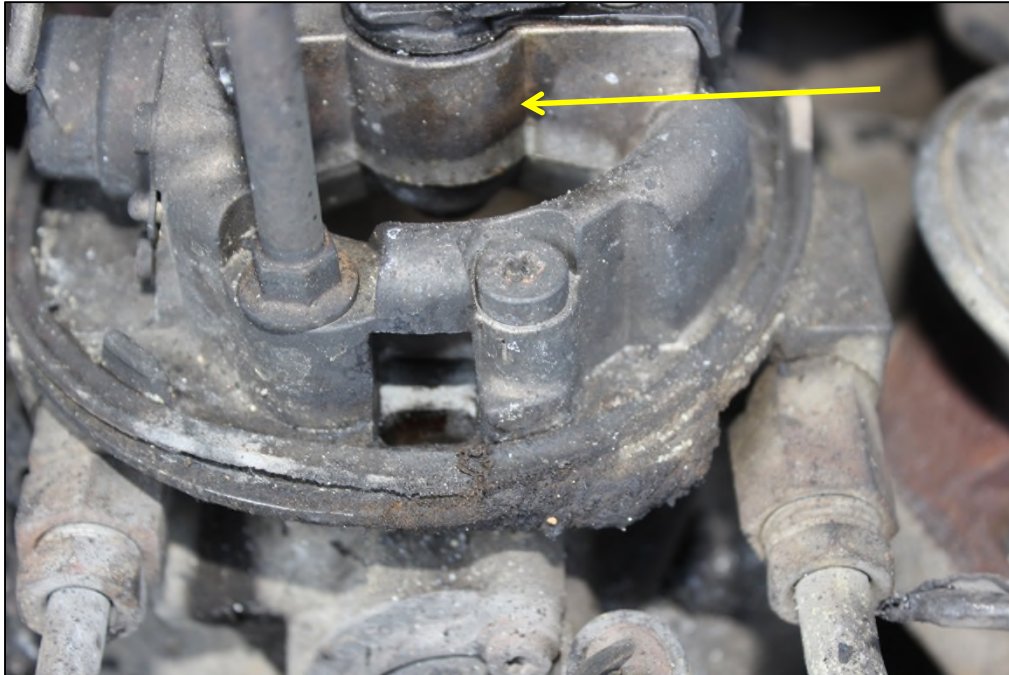
Photograph 15

A closer view of the carburetor, observe the discoloration to the top portion of the carburetor.

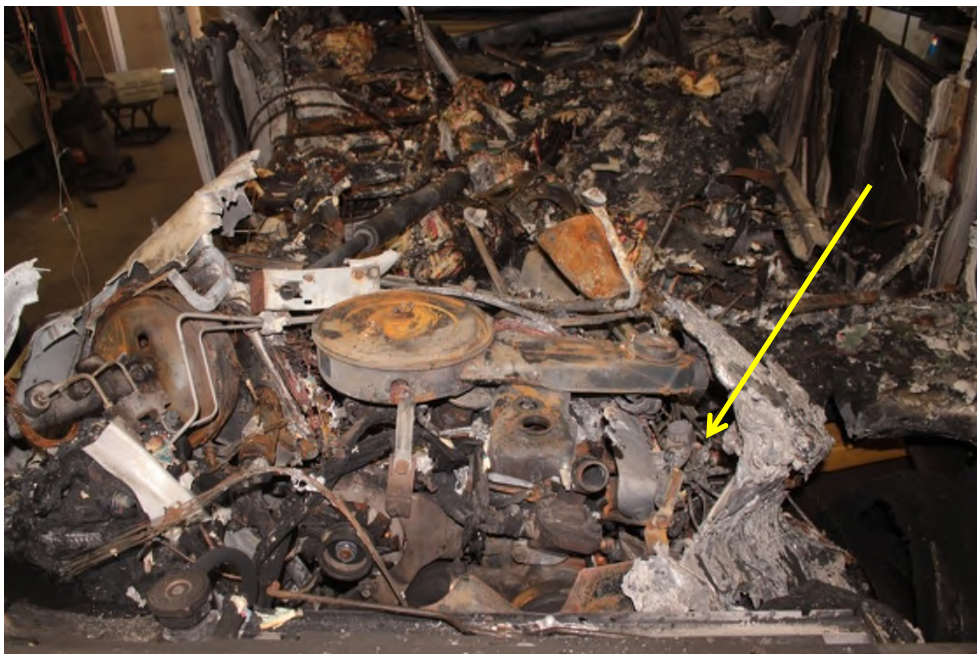
Photograph 2

Engine compartment, foreground. General area of origin, yellow arrow.

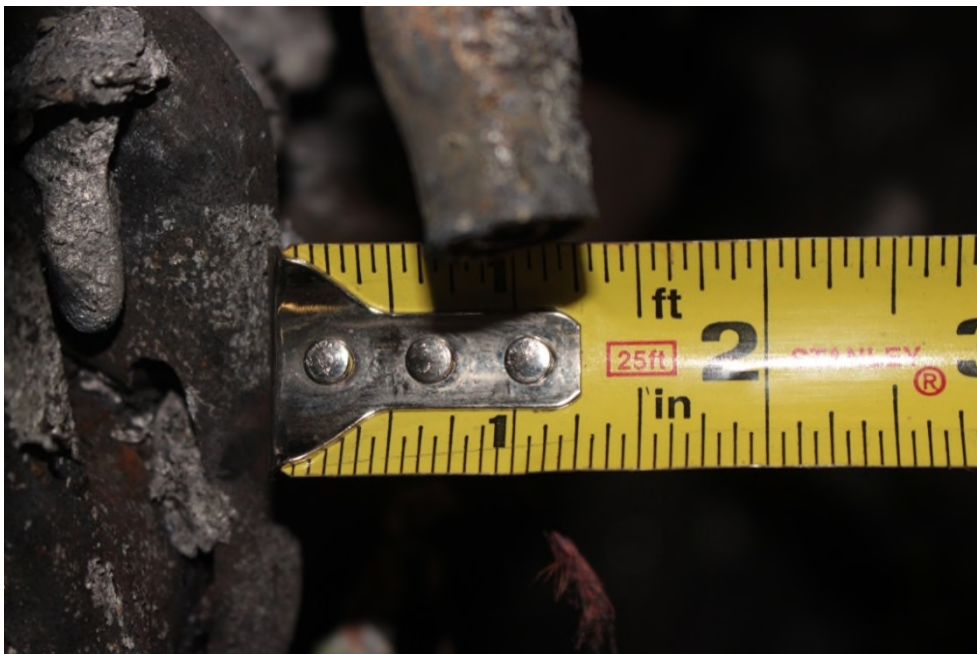
Photograph 4

Fuel line connector, top center, clearance to exhaust header flange.

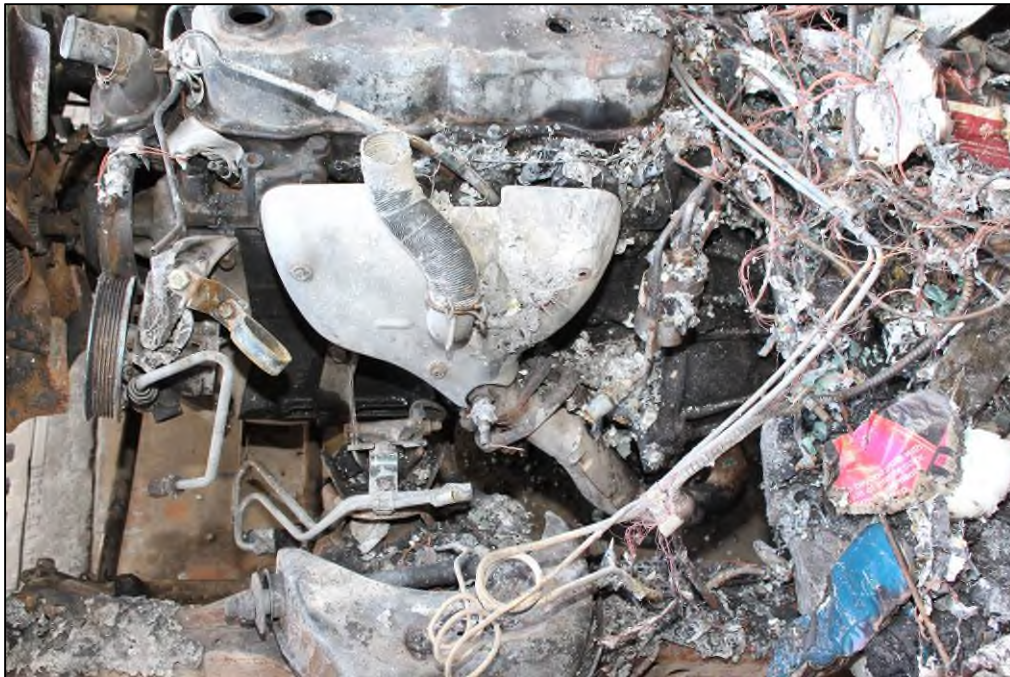
Photograph 5

Left side of engine compartment; area of fire origin.

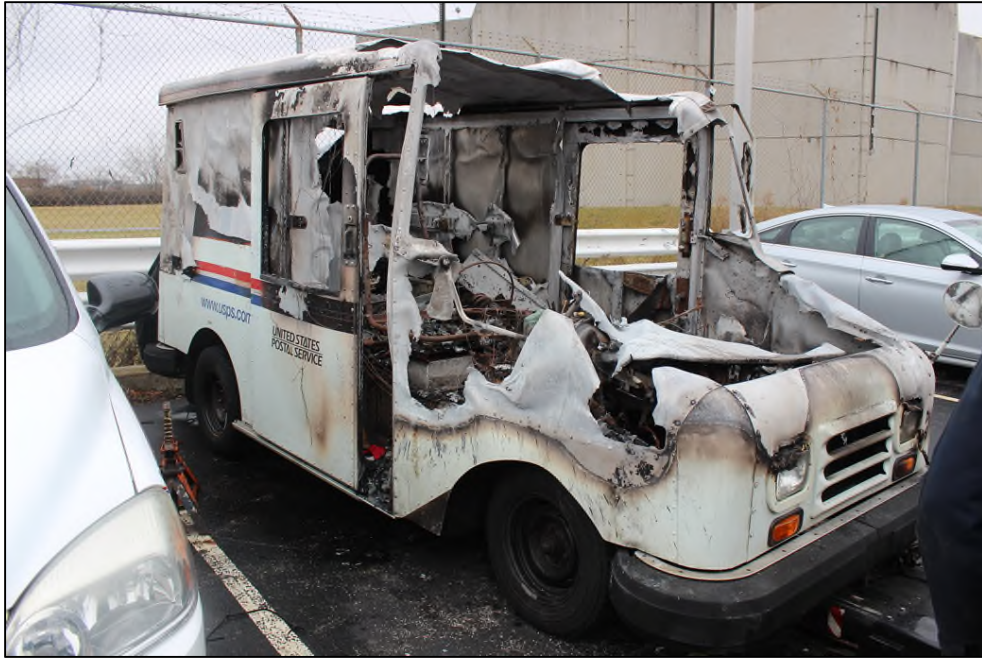
Photograph 1

Front of LLV with fire patterns extending from engine toward the rear.

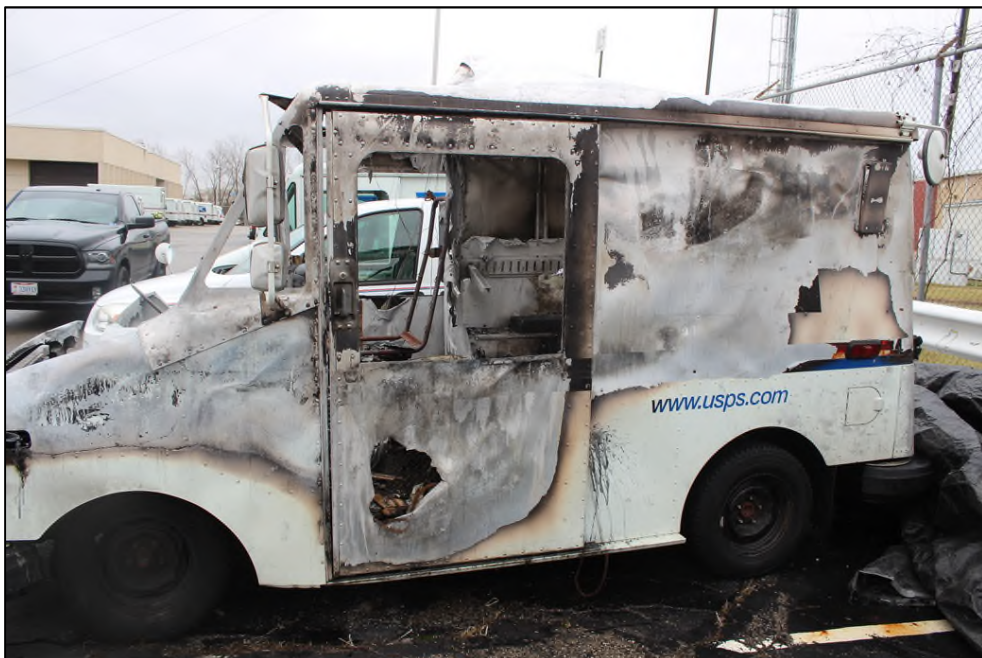
Photograph 2

Left side of LLV with fire patterns extended from the engine compartment.

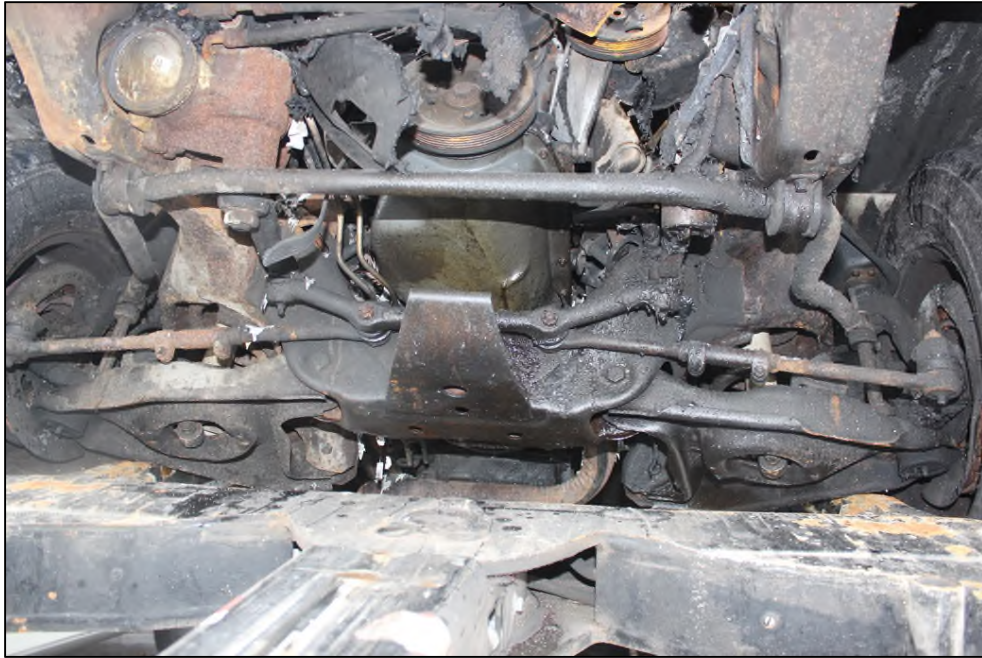
Photograph 3

Underside of engine with heavy oil residue on the left side components.

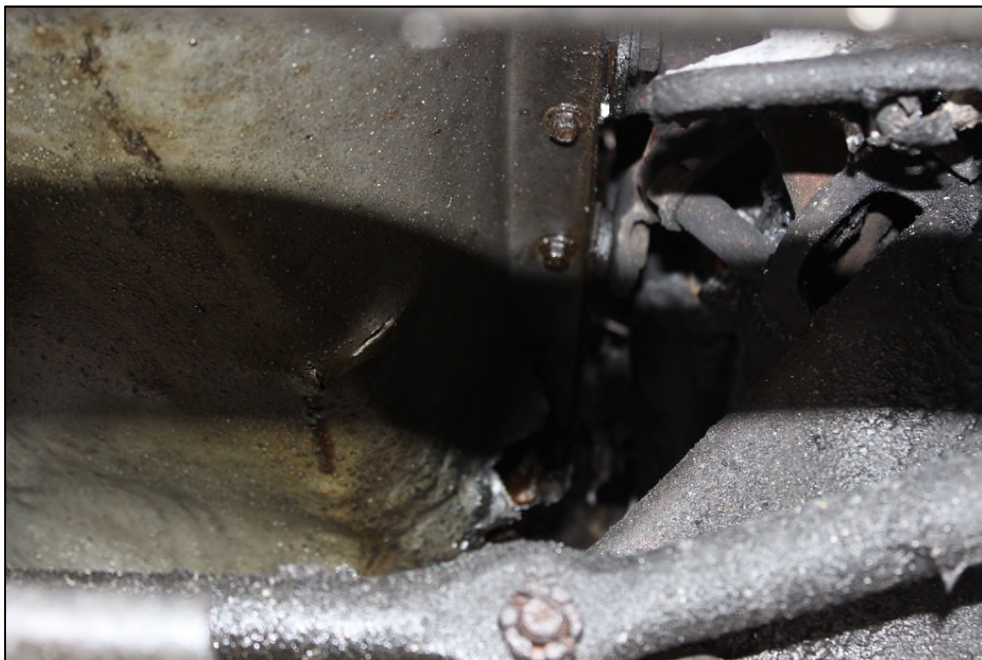
Photograph 4

Left side of oil pan fractured with hole and oil residue.

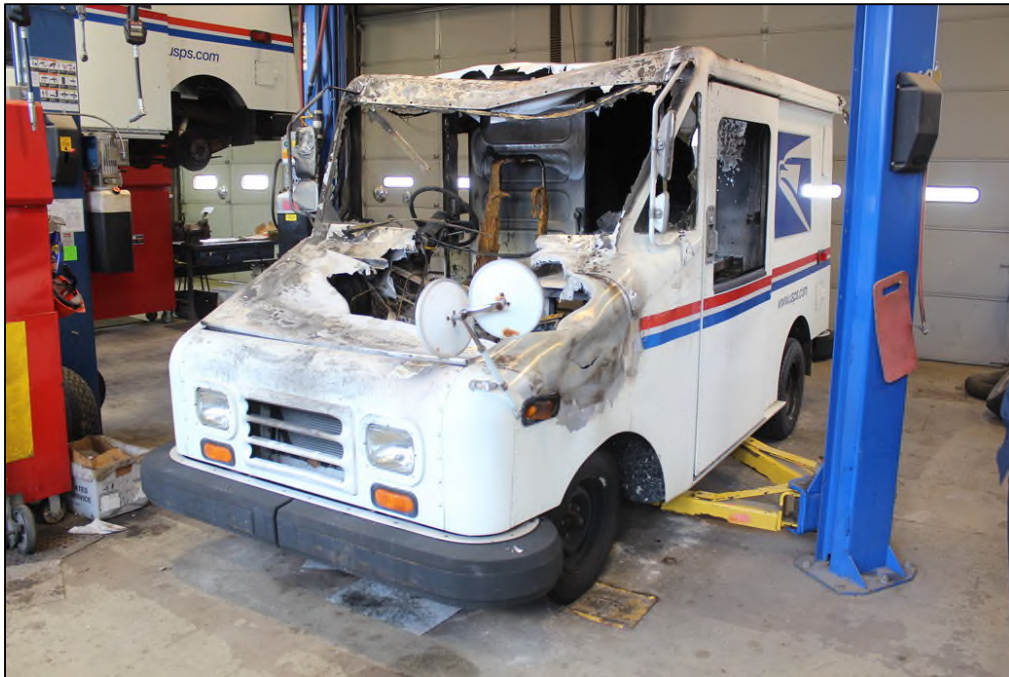
Photograph 1

Fire damage patterns indicating fire extension from engine compartment.

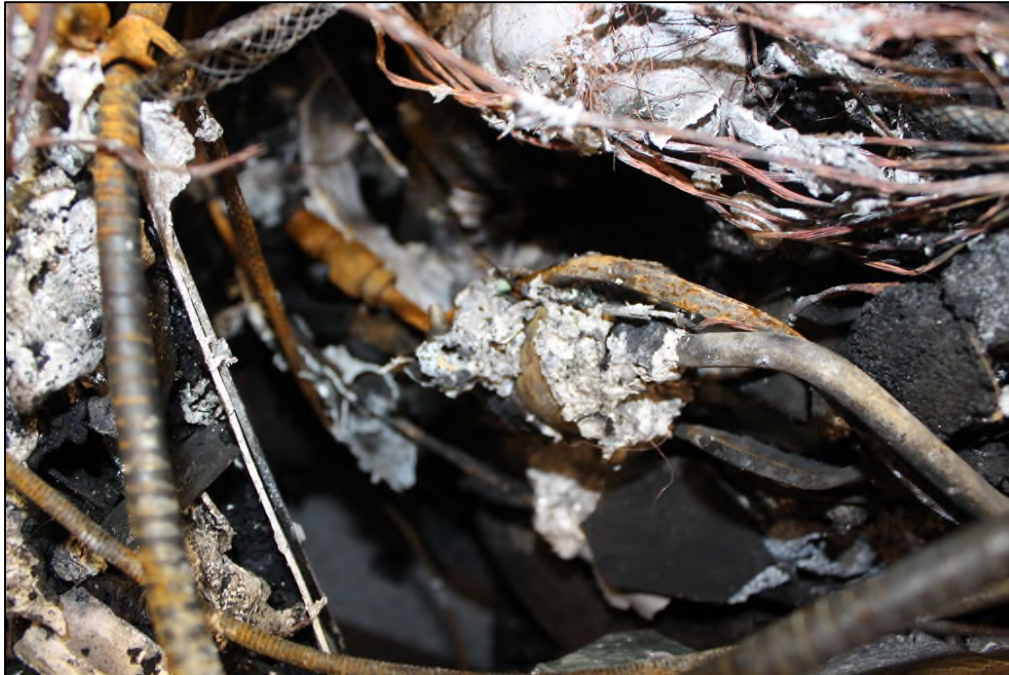
Photograph 3

Fire damage and molten aluminum on top of the fuel filter.

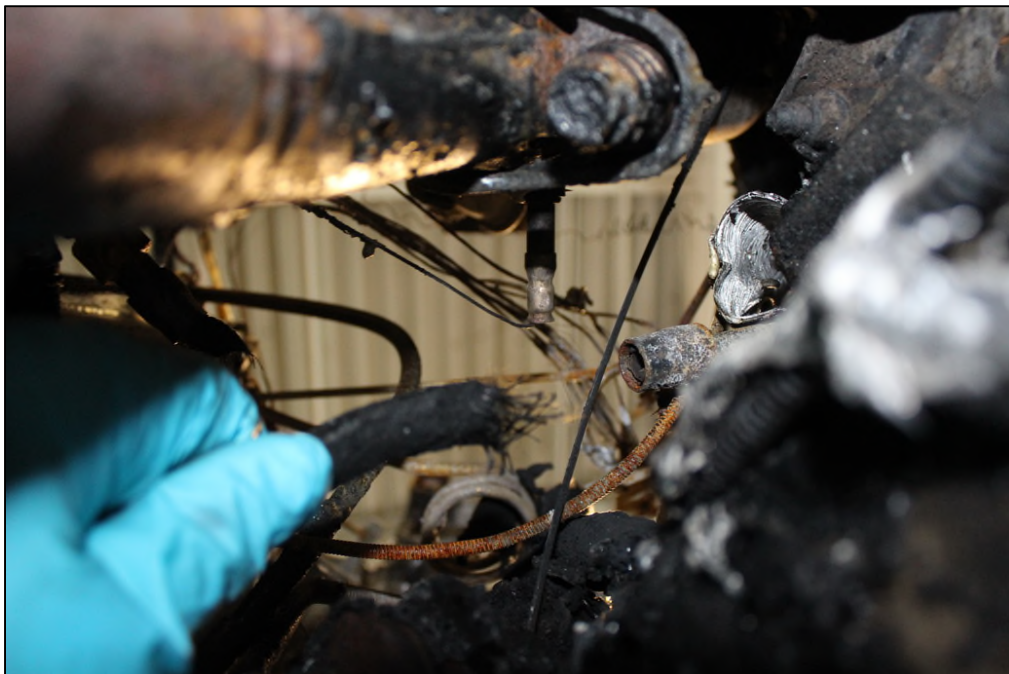
Photograph 4

Fuel filter supply side hose fractured at the pressure fitting bottom side.

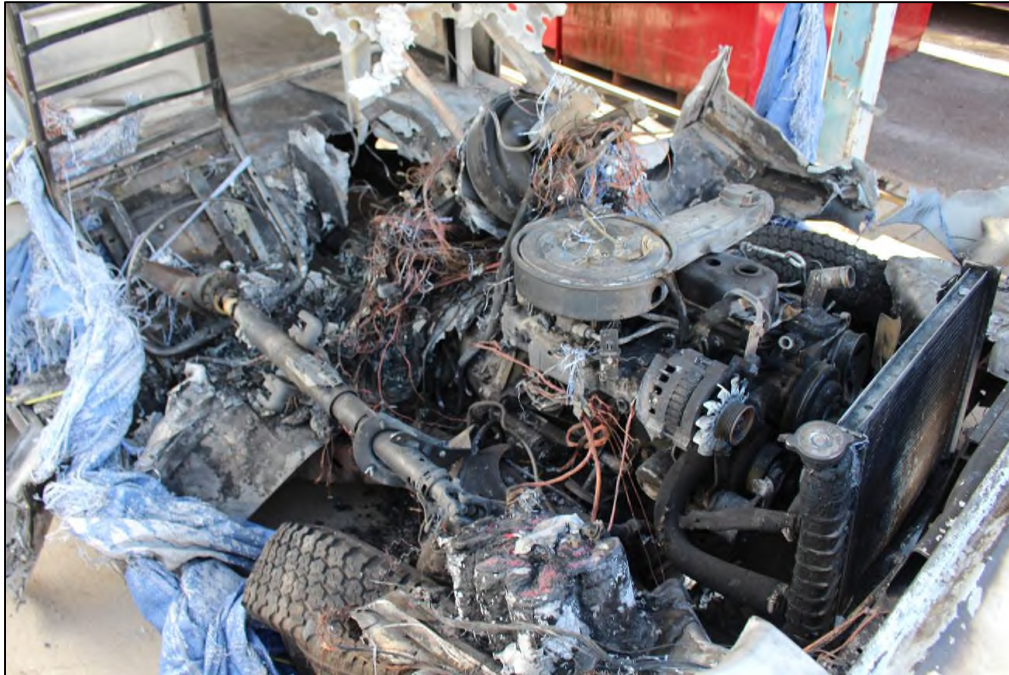
Photograph 6

Profile view of right driver side of engine compartment where fire originated.

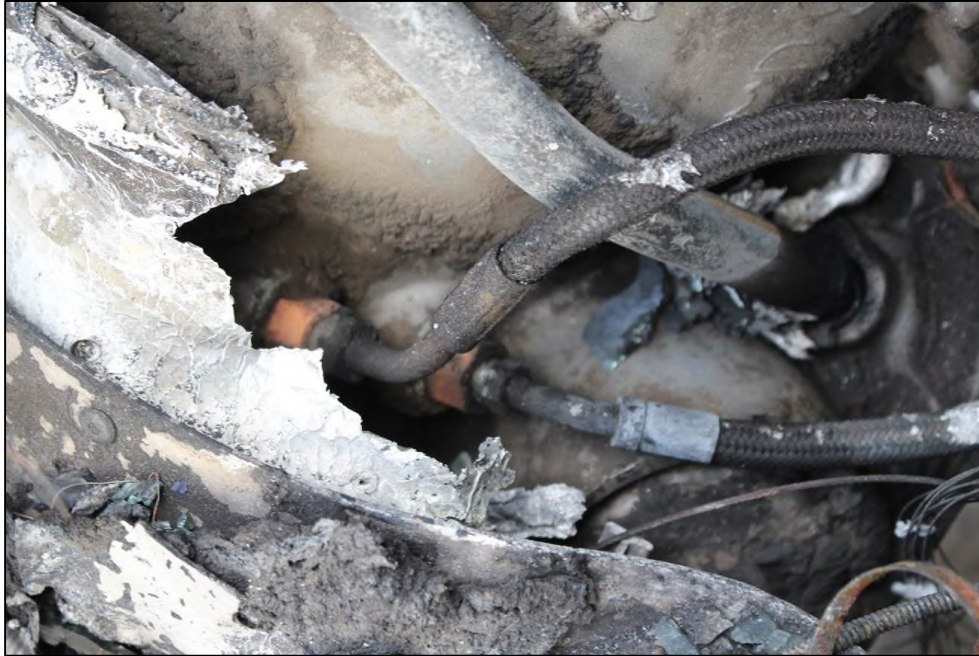
Photograph 8

View of transmission cooler hose at its point of connection to the transmission case on the right driver side of the vehicle. The hose was replaced by Pep Boy's prior to the fire's occurrence.

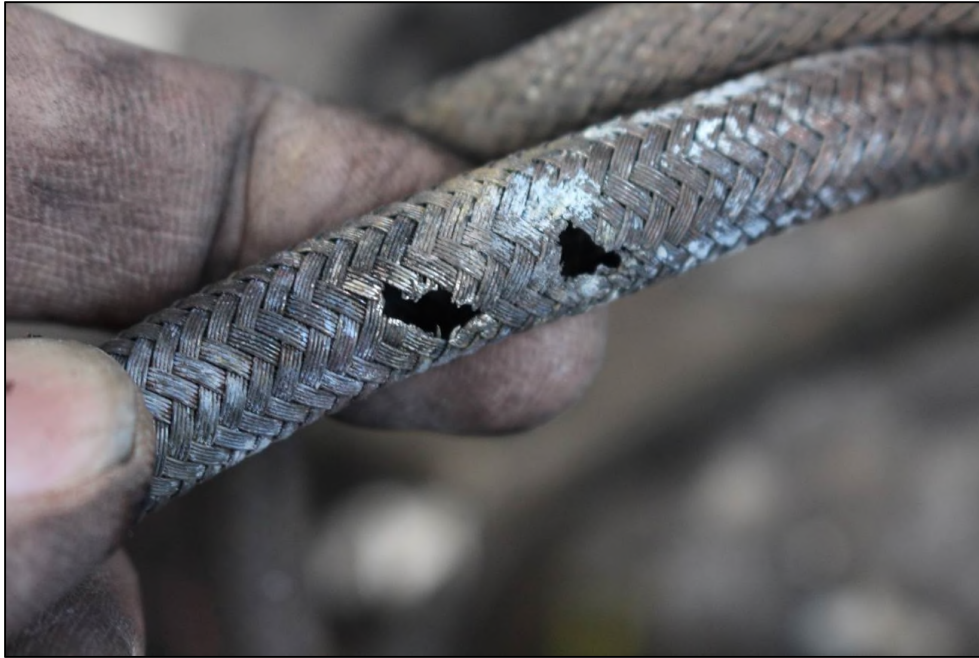
Photograph 10

Corresponding arc damage associated with steel braid of transmission cooler hose caused by contact with positive cable connection at starter.

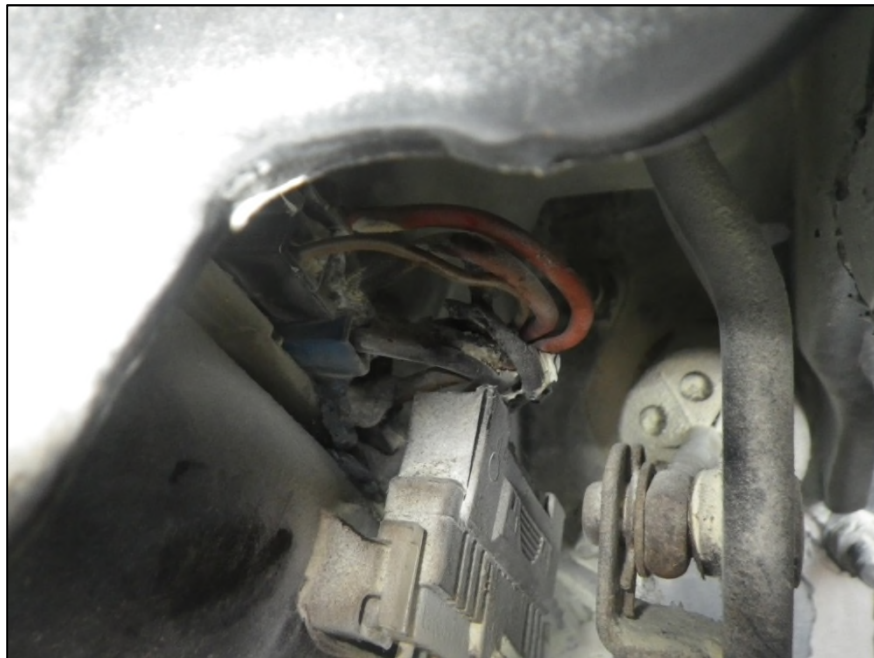
Photograph 4

View of fire damaged ignition switch and wiring, on top of steering column.

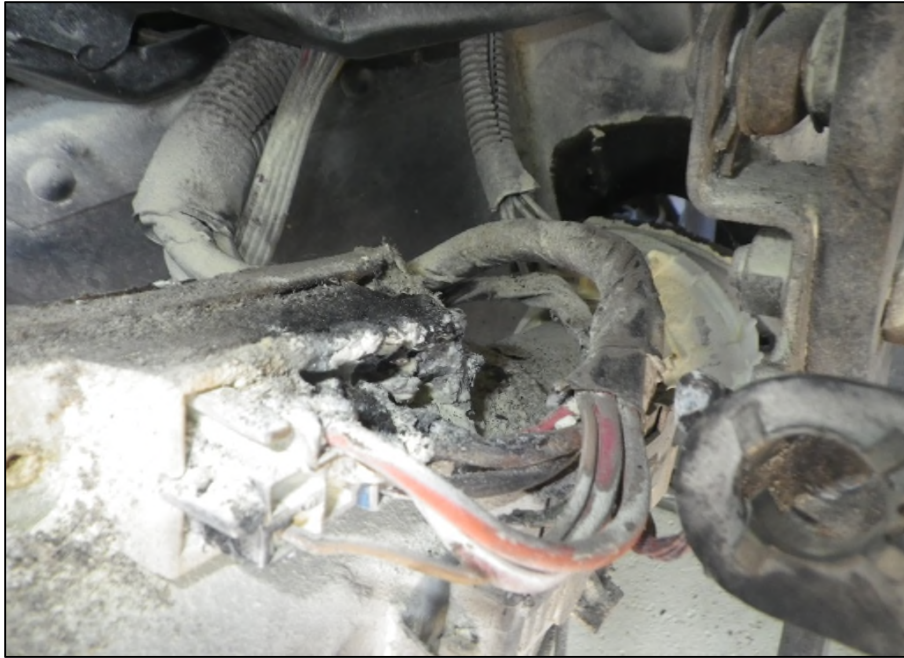
Photograph 5

View of fire damage where connector shorted out on ignition switch.

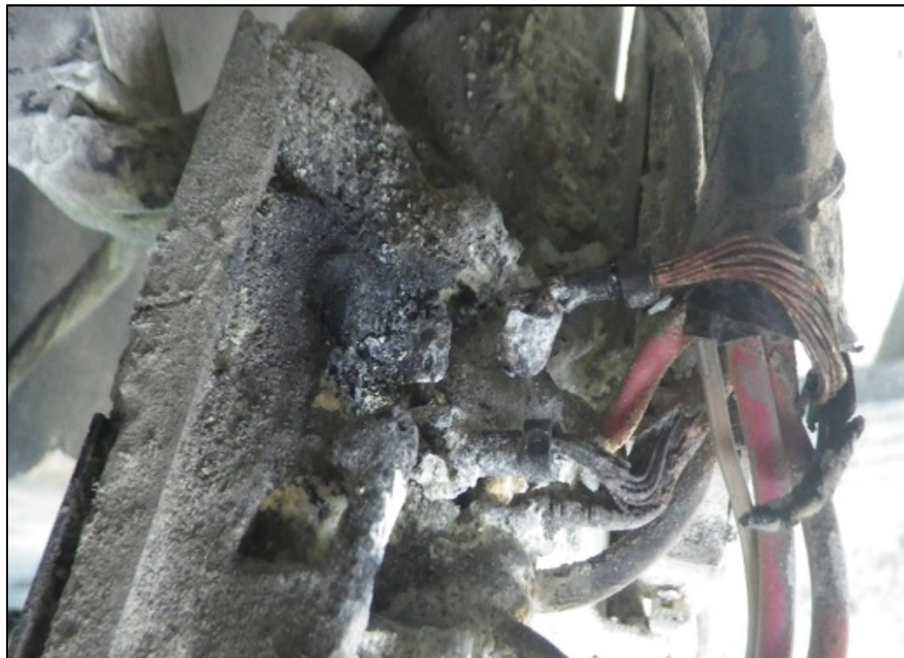
Photograph 6

View of shorted connector and spade of ignition switch.

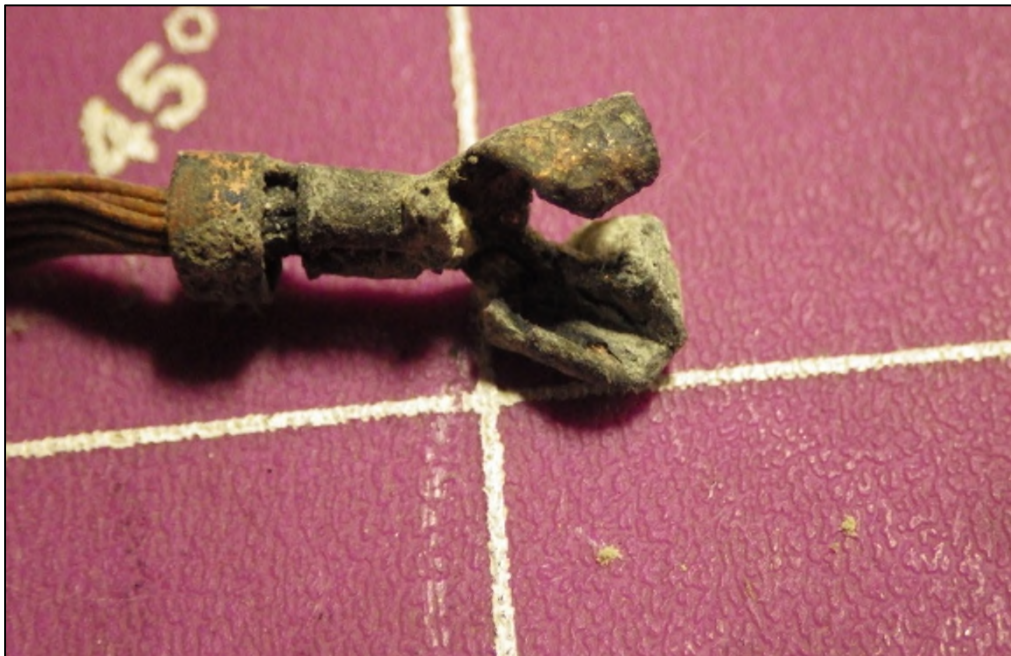
Photograph 10

Mechanical damage to the wire terminal connector.

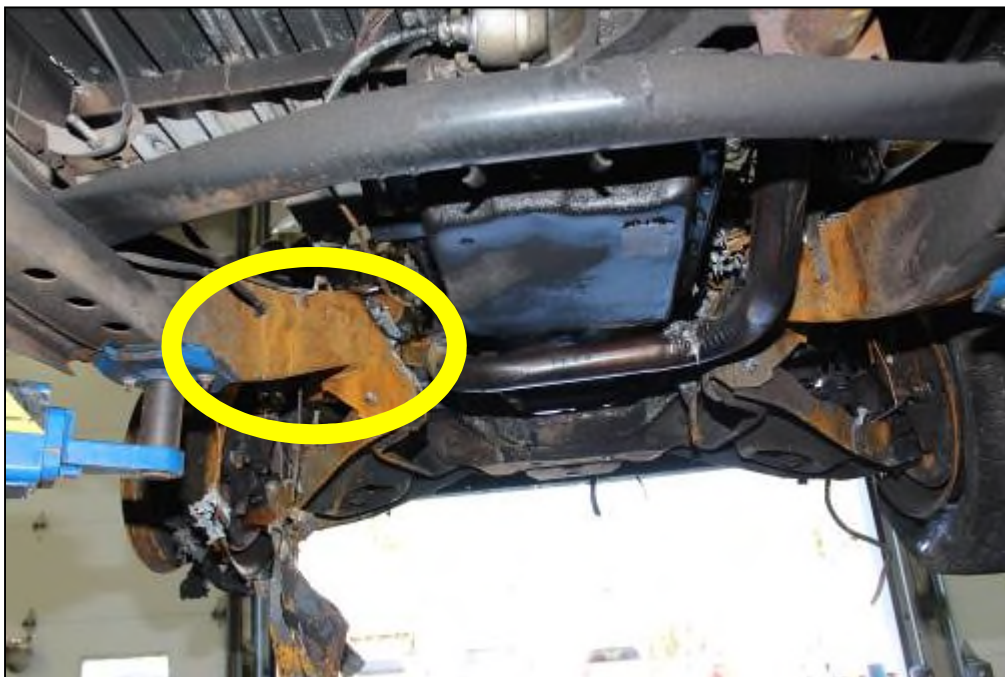
Photograph 10
View of the undercarriage and fire damage to the left frame rail.

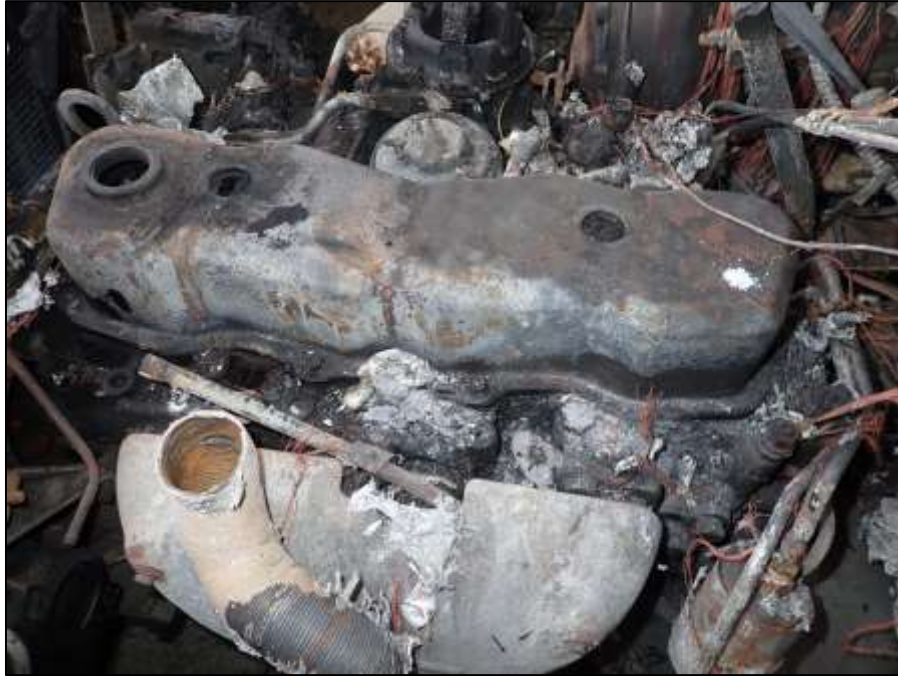
Photograph 3

Mail side of engine compartment, close-up.

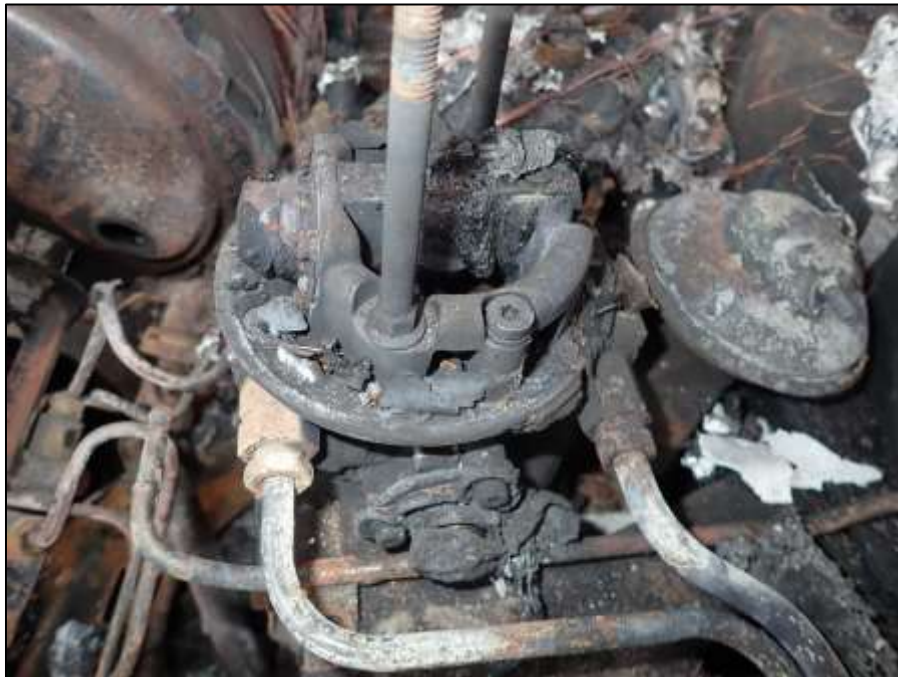
Photograph 4

Carburetor.

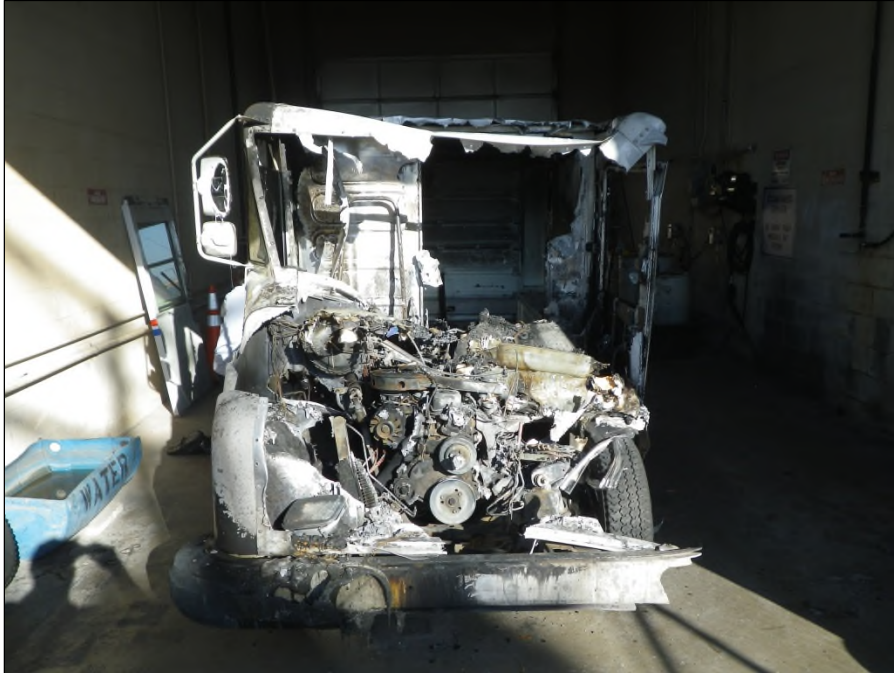
Photograph 1

Exterior examination of the vehicle revealed severe fire damage to the engine and operator's compartments, and moderate to severe fire damage to the cargo compartment. An analysis of the exterior fire patterns indicate that the fire originated in the engine compartment of the involved LLV.

Front view of fire-damaged vehicle.

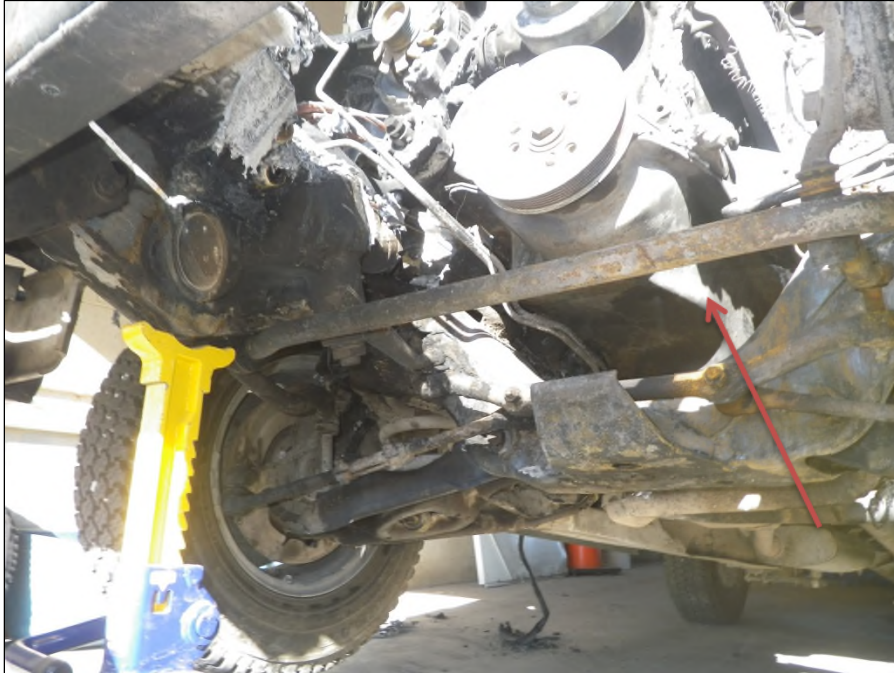
Photograph 3

Examination of the undercarriage revealed evidence of fire damage in the areas of the bottom side of the engine, as well as the sides of the engine. The involved vehicle was mounted on an S frame. In the area of origin, which was on the mail holder side of the

engine in the oil pan area, an approximate 1" x 1" hole was observed, which indicated that a rod, or other engine components, had possibly exited out the side of the oil pan, causing oil to spill from the hole and onto the hot engine and hot exhaust system within close proximity of the hole.

View of underside of vehicle. Arrow indicates area of hole in oil pan.

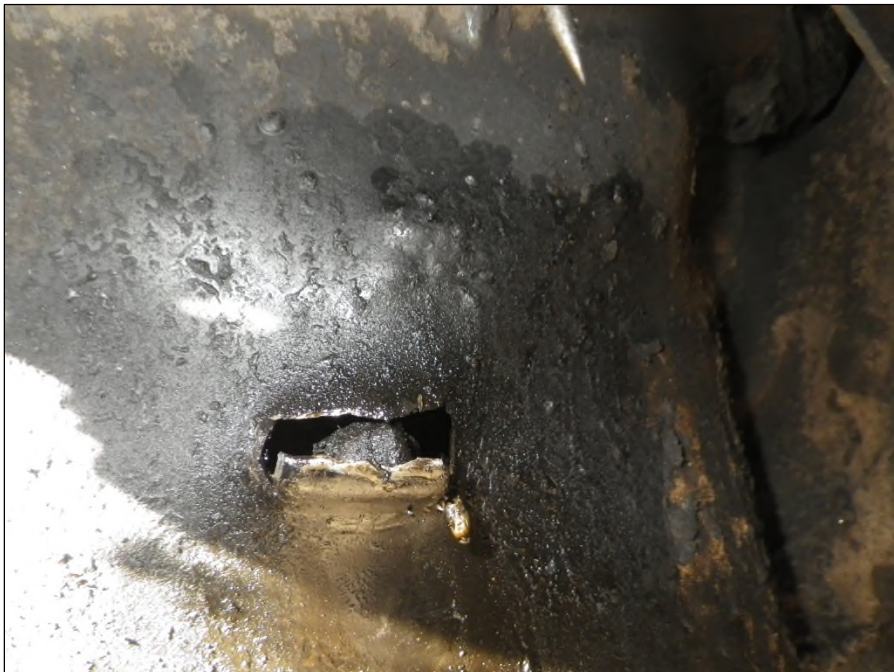
Photograph 4

3. The specific ignition sequence and cause of the fire was determined to be the direct result of mechanical damage within the engine which caused a hole in the oil pan and ignition of the oil on the hot surface of the operating engine.
4. The day prior to the fire, the LLV had been inspected by a service technician who determined that the LLV had major engine problems and instructed the postal supervisor to take the vehicle out of service. The vehicle was not taken out of service and returned to the route the next day when the subsequent fire occurred.

View of hole in oil pan.

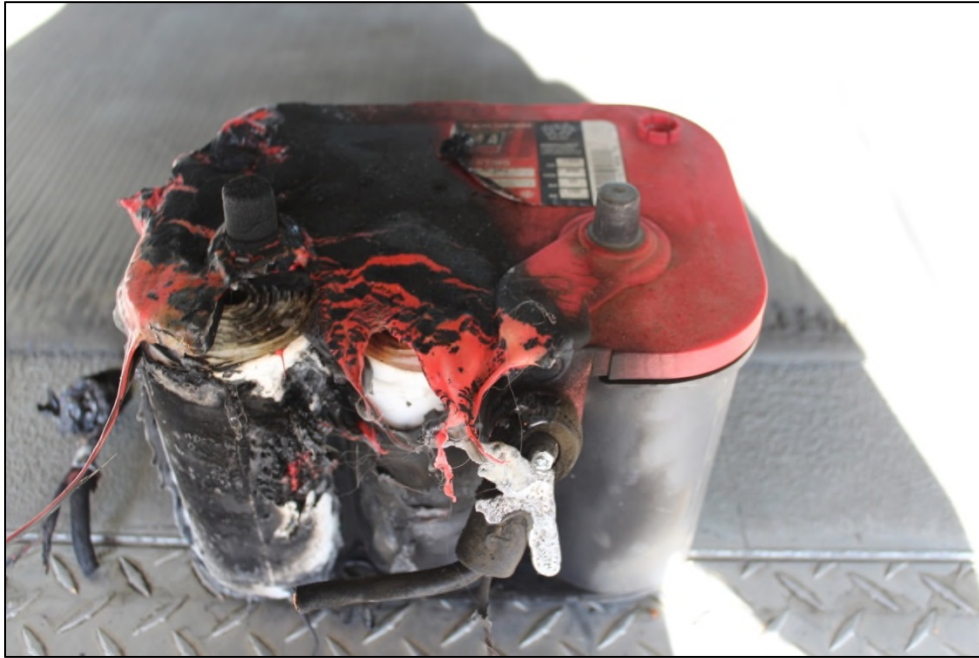
Photograph 3

The failure or malfunction of the battery is unknown pending a laboratory examination by an engineer.

Optima Red Top Group 34 vehicle battery, part number SC34U.

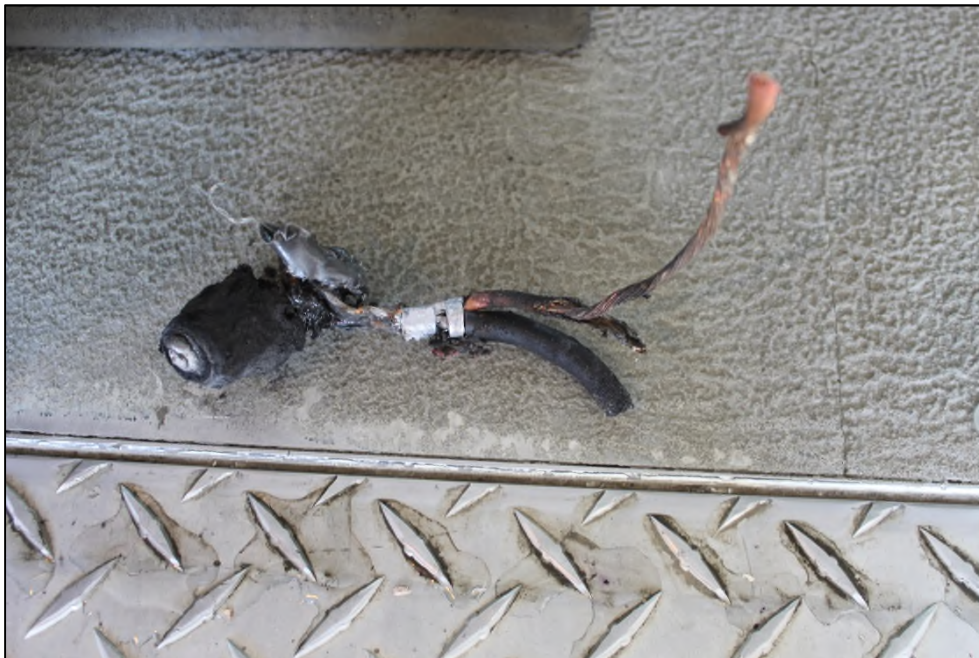
Photograph 4

We examined the electrical conductors that led from the battery terminals and did not observe any adverse electrical activity or failure to the vehicles electrical system. We examined the alternator and starter and did not observe any adverse electrical activity or failures. The oil level was checked and was approximately 1 quart low. The transmission fluid level was at an acceptable level. Based on the fire patterns observed, the battery was determined to be the point of origin.

Positive side battery post.

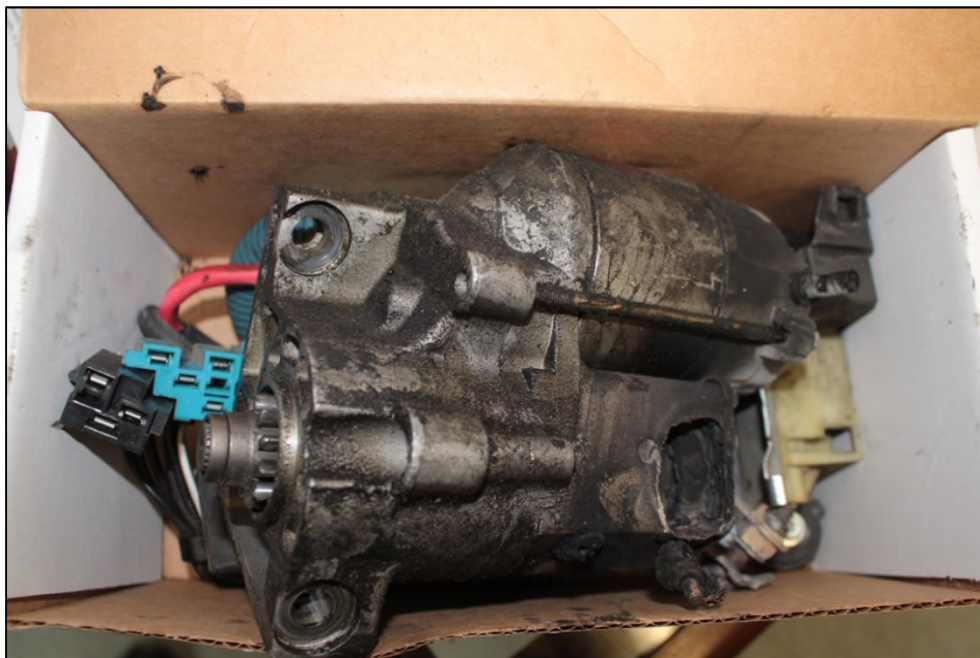
Photograph 2

Failed starter motor solenoid.

Starter motor and related components.

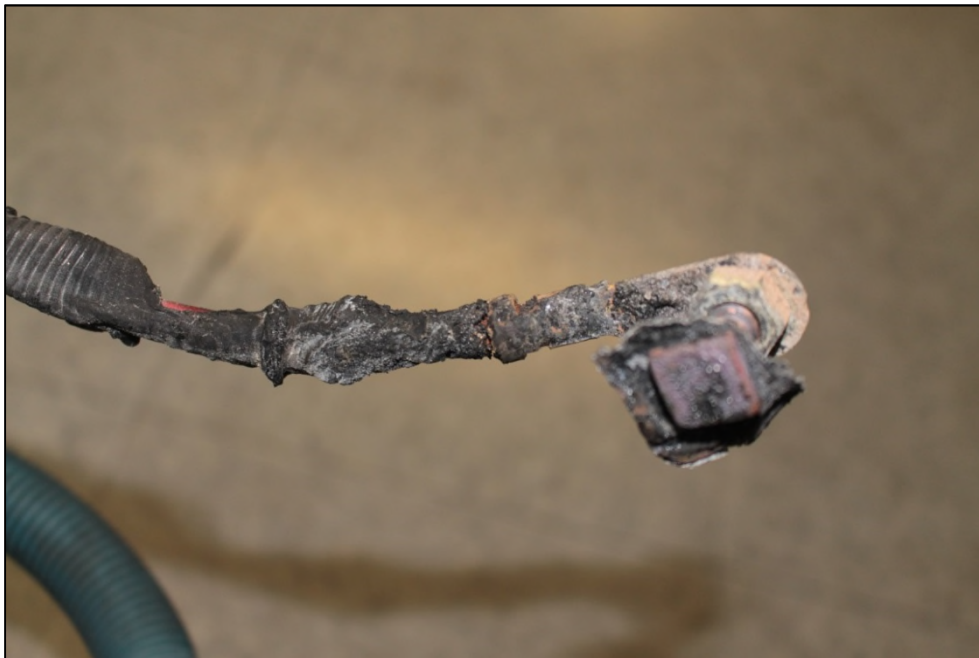
Photograph 4

Battery cable section where connected to starter motor.
